Survey Findings on accessible temporary toilets

- Access Institute
- WALGA
- Disability Services Commission
- Commonwealth of Social Services
- Equal Access
- People with Disabilities (WA) Inc
- Spinal Cord Injuries Australia
- Spine and Limb Foundation
- Disability Advocacy Network Australia
- People With Disability WA
- Australian Federation of Disability Organisations
- Ages and Disability Advocacy Australia
- Independence Australia
- Ethnic Disability Advocacy Centre
- Changing Places Australia
- National Disability Services WA
- Ability Centre
- Spine and Limb Foundation

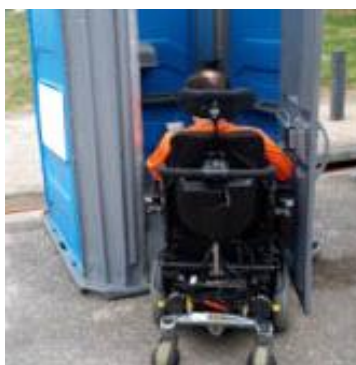
Figure 1: Picture showing accessible temporary toilet style A not meeting the needs of a wheelchair bound patron (Bromley, 2014).

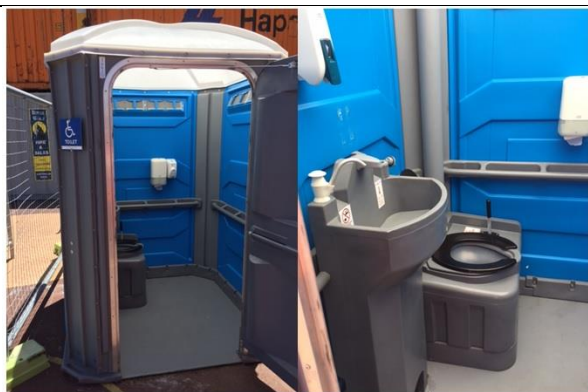
Figure 2 WA accessible temporary toilet Style A (Photo DOH Dec 2016)

Specifications

- Waste Tank – Capacity 125 Litres
- Fresh Water Tank – Capacity 151 Litres

Dimensions

- Height – 2310 mm
- Width – 1570 mm
- Depth – 1570 mm
- Door opening width – 810 mm

The responses to each of the design elements identified were mainly negative (Figure 7). The main theme identified was lack of space, specifically:

- Narrow door
- No room for additional persons
- No changing space
- No circulation/manoeuvring space
- No space for legs under the sink
- No space for side transfer
- No storage space for medical supplies or other items

These results are concerning for the DOH as it indicates that the most common toilet type provided for wheelchair access, is designed such that:

1. wheelchairs cannot get through the door
2. they do not have enough circulation space and
3. users cannot transfer onto the toilet.

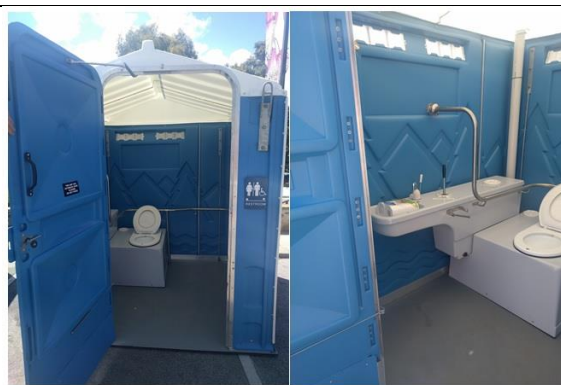
Figure 3 WA accessible temporary toilet Style B (Photo DOH Dec 2016)

Specifications

- Waste Tank – Capacity 190 Litres
- Freshwater Tank – Capacity 100 Litres

Dimensions

- Height – 2305 mm
- Width – 1956 mm
- Depth – 1956 mm
- Door Opening width – 820 mm

Positive themes were identified as follows:

- More space than Style A
- Solid Grab rail
- Some bench space for resting supplies on

- Potentially room for one carer and wheelchair to be in and manoeuvre about whilst the door is closed
- Side and front transfer option

Whilst there were less negative responses, concerns were raised regarding the following:

- Location of flush mechanism – may not be able to reach whilst sitting on the toilet
- No provision of a rubbish bin or hanging hooks
- Designed for wheelchair users so doesn't acknowledge the needs of all other accessible toilet users
- Internal door handle is too small and is located too high for a person on a wheelchair to reach
- Door is not self-latching
- Potential that the grabrail will get too hot in sun to allow for comfortable transfer
- The sink may be too small

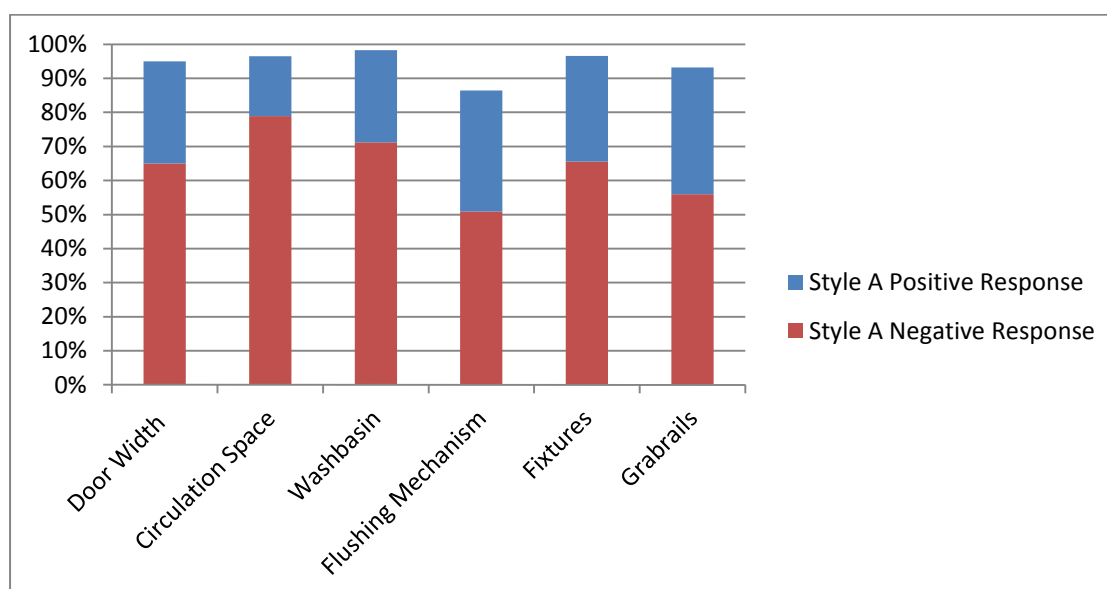
Figure 7 Accessible temporary toilet Style A

This toilet did have some positive response from the Mobility Aid Users indicating that this toilet style could be reclassified as an ambulant or family friendly toilet for families without a member who has a disability.

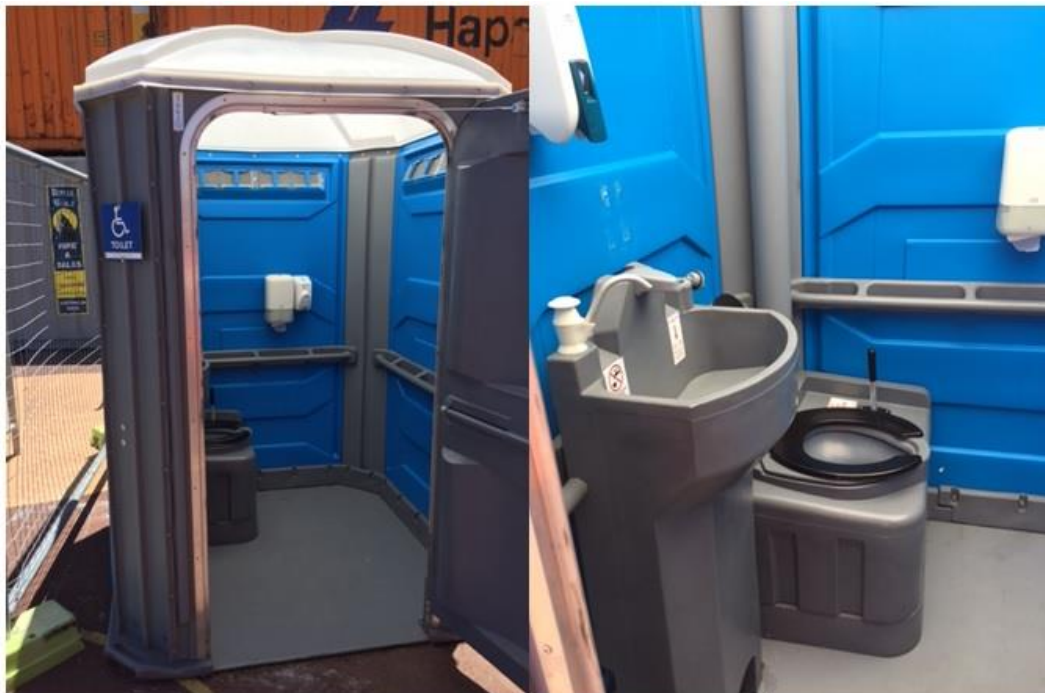
Users were then shown the following picture of a toilet called toilet Style A

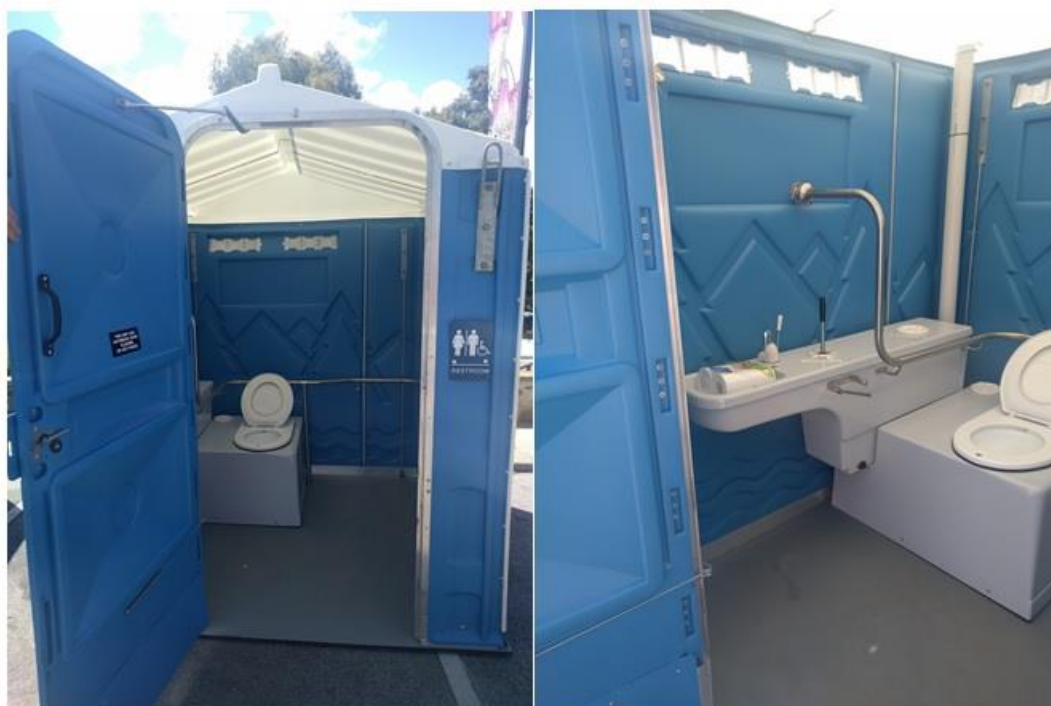
Users were then shown the following picture of a toilet called toilet Style B
