TRAUMA CASE OF THE WEEK

Case Eight

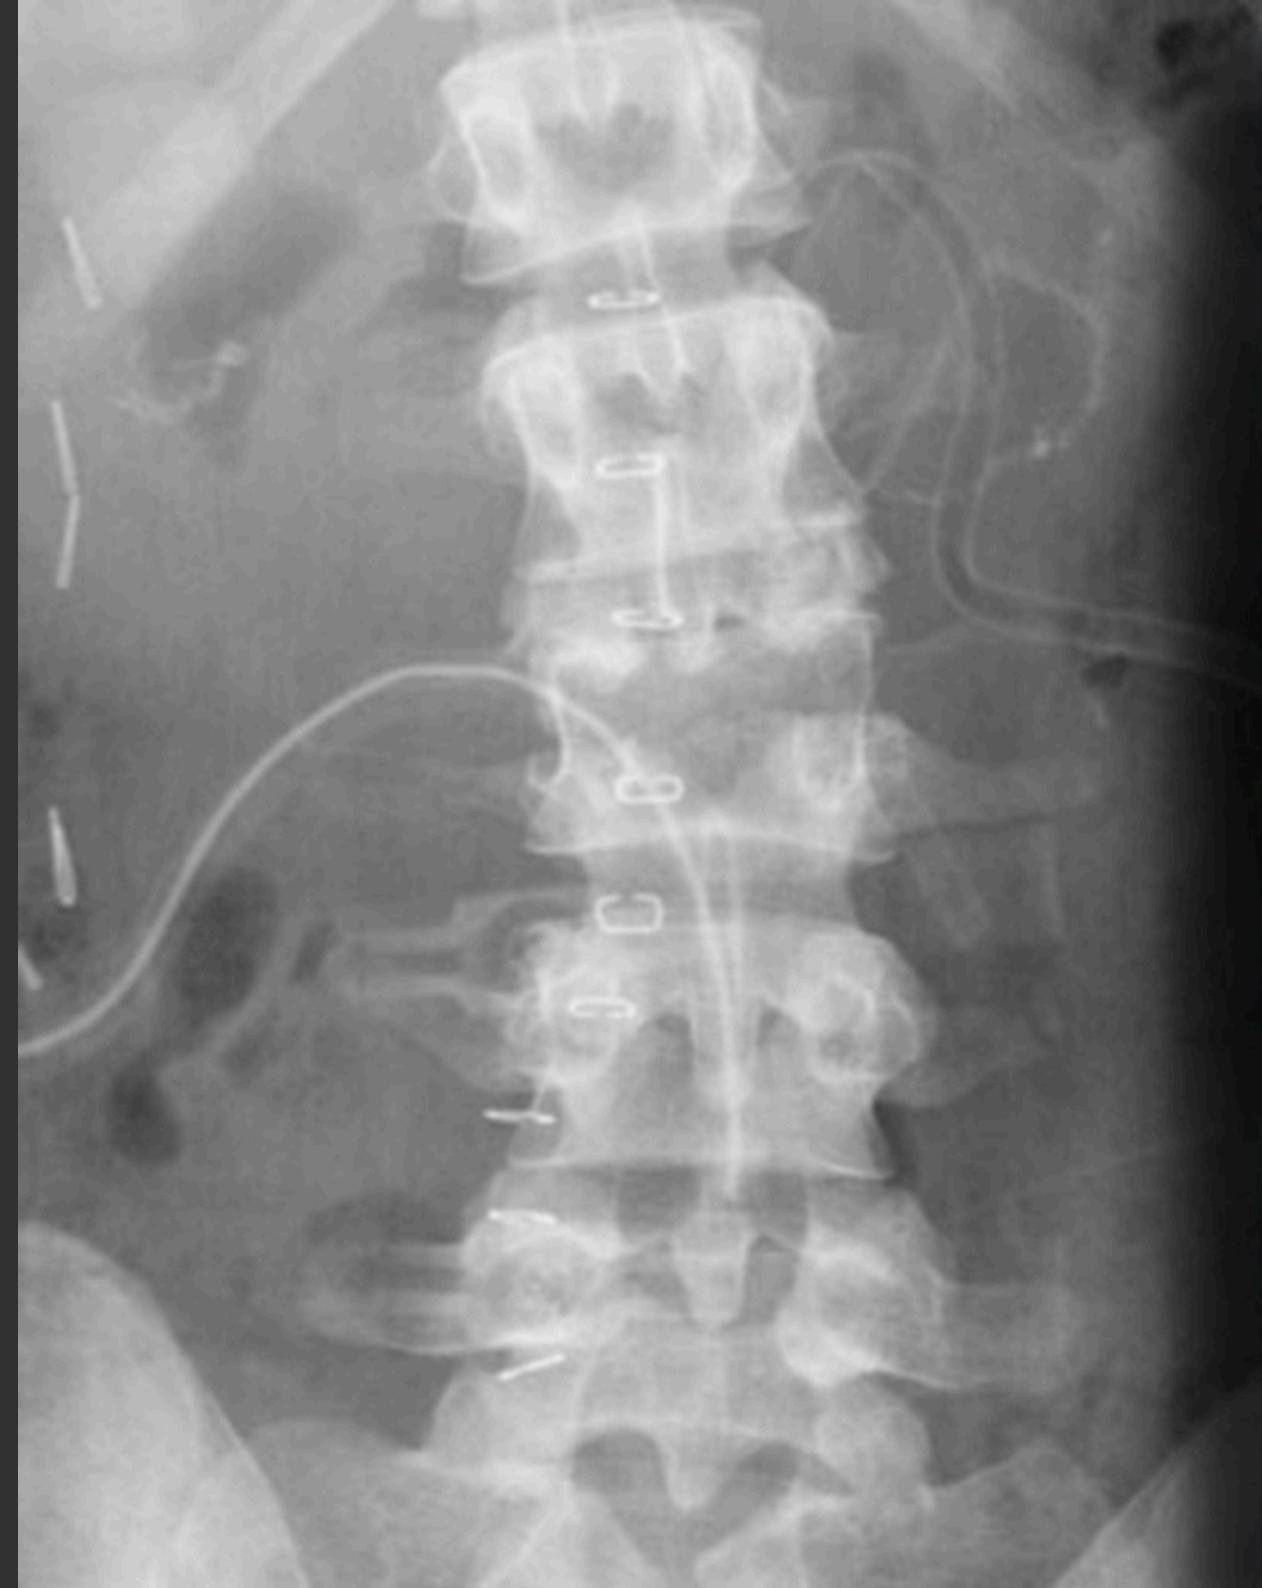
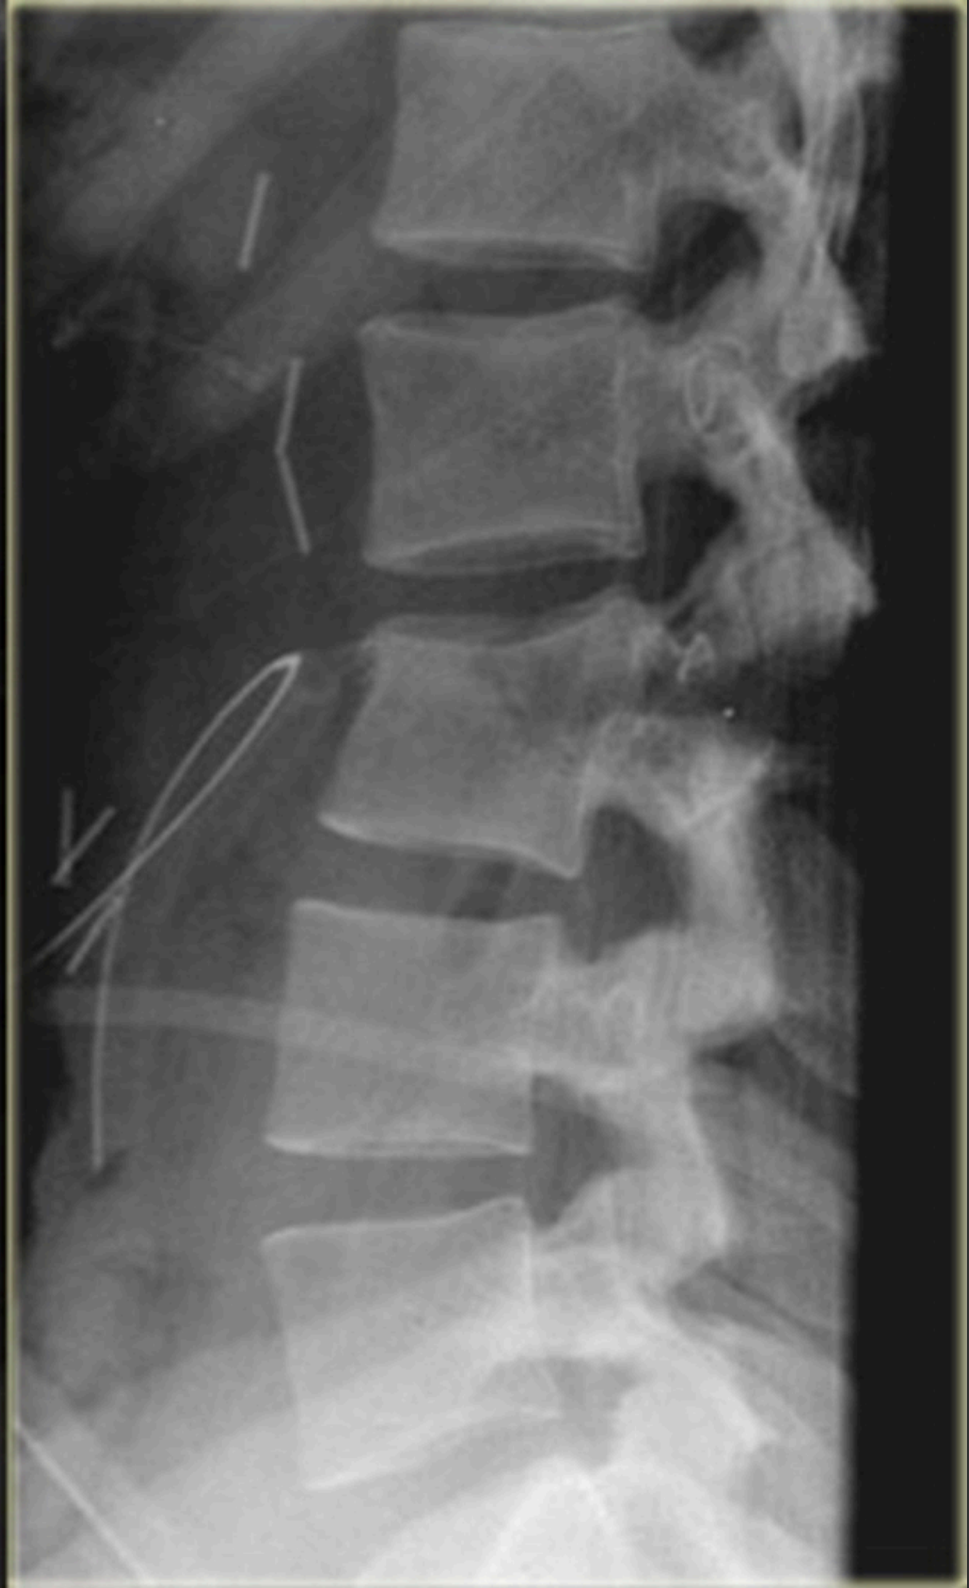
The Xray shows what is known as a “Chance” fracture (named after the surgeon who first described it). The fracture line is easier to discern on the lateral image. The abnormalities lie at the L3 level.

The anterior border of the vertebral body is compressed in comparison to the posterior, there is a fracture line that extends almost horizontally through the body, and the fracture line continues through the posterior elements (pedicles and laminae). On the AP image the fracture is harder to see but there is marked separation of the fractured parts of the pedicles, and of the spinous processes above and below the fracture. Most are at T12-L2.

The Chance fracture is a horizontal shearing injury caused by violent de-acceleration, in this case probably around a poorly fitted lap belt. The de-acceleration/shearing disrupts all 3 spinal columns (anterior bodies, posterior bodies & posterior elements) and so is an unstable injury. Once recognised this must be treated as an unstable injury with application of full spinal precautions. Only log roll these patients with extreme care.
